BALL BEARING STEERING DAMPERS

By Bill Button

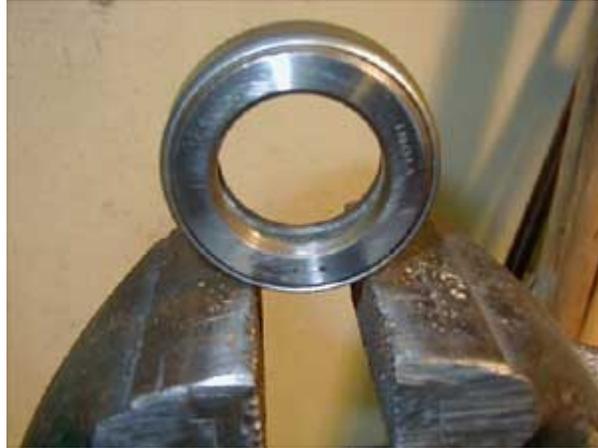
In order to stop the "Dreaded Morgan Wheel Vibration" the Morgan Factory installs a brass plate with a damper blade clamped to the frame. There is considerable friction between the stub axle and the brass plate. In order to reduce this friction there are a couple of ways to install bearings. 1) a Thorsen bearing which uses needle bearings and is about 3/16" thick and 2) a Ball Thrust Bearing which is 5/8" thick. The Thorsen Bearing is used by several Morgan Owners with success. However I feel it is too vulnerable to dirt, & rust. Thus the Ball Bearing. These bearings cost about \$25 USD each. One lip is 1 7/16" and will press onto the stub axle barrel. The other lip is 1.485" just slightly larger so that the bearing can turn. By relocating the grease hole .25" and plugging the old hole the bearing will be automatically greased from the stub axle (same as with the brass plate).

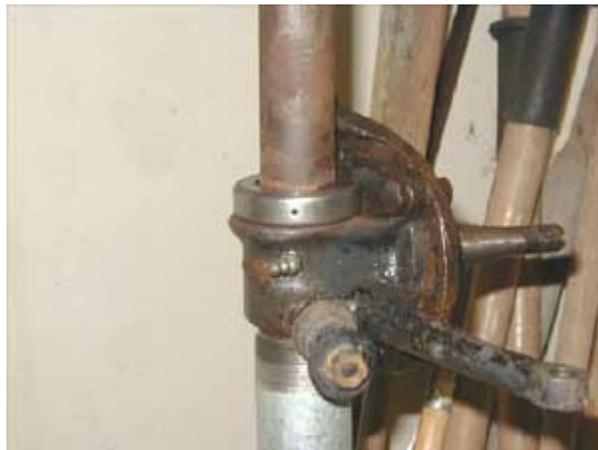
Here you can see the bearing mounted on the stub axle. The little hole is for greasing with a grease gun with a tapered fitting. Grease will come out here as well as on top of the bearing. As you will recall it is a little bigger than the pipe. This could be a problem as water and dirt can travel down the pipe and into the bearing. Maybe an "O" ring will help or some sort of rubber/ribbed tube that will cover the springs as well as bearing.

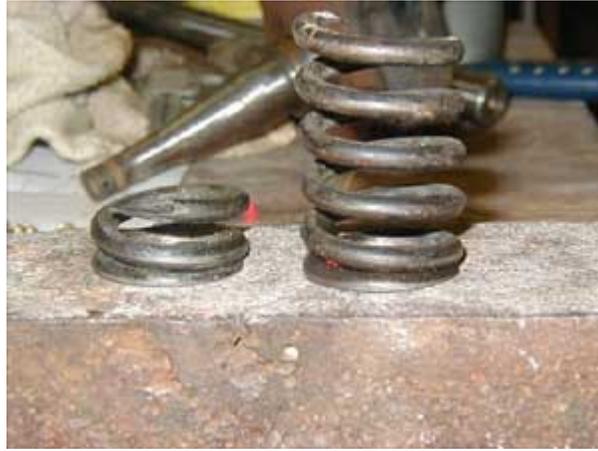
I cut the rebound spring removing 2 coils. Just trying to give the stub axle room to move. I may shorten the upper spring. However I will take it to a "Spring Company" so that I get the proper hardness etc.
