Warning – Wire Wheel Rear Brake Drums

by Ken Miles

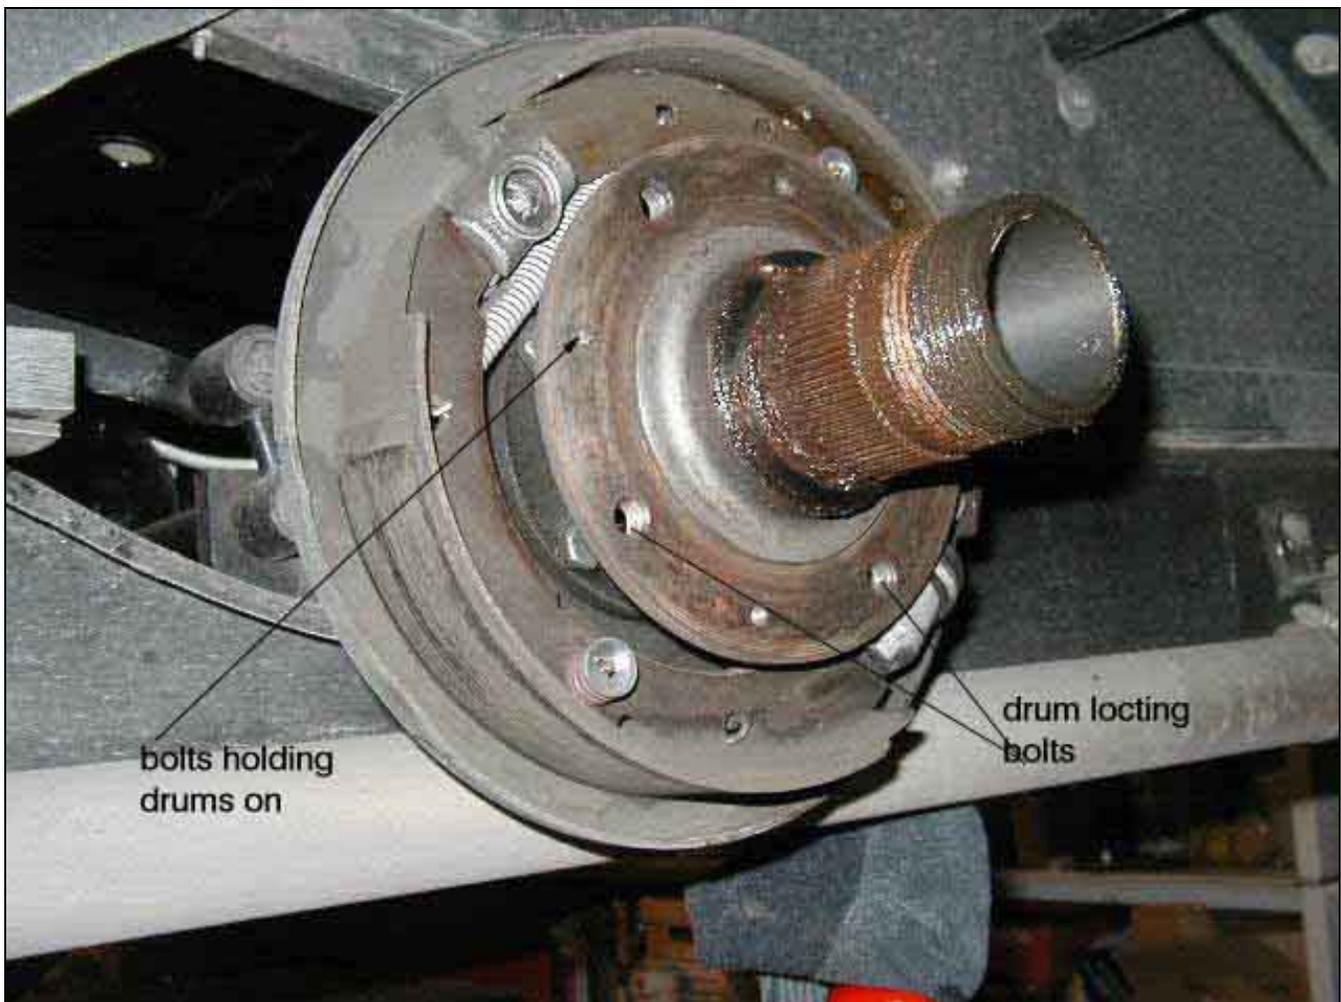
As you know I bought new splines for my wire wheels after I restored the 4/4. They came equipped with positioning bolts to hold the drums in place. These are large bolt heads that look like huge slot screws that I thought were firmly fixed into the splined hub backing plate. Unfortunately they came out sometime and this allowed the drum to be held in place only by the bolts that hold the drum to the spline. These bolts eventually sheered allowing the drum to rotate with the wheel when the brakes were applied.

So please if you have new splines check your positioning bolts or get someone with knowledge to check them for you. The attached picture shows the splined hub immediately after I took the drum off with no positioning bolts and only two sheered off holding bolts. Note I remove the wheels every year and clean and inspect them and a year ago all these bolts were in place with on 8000 miles on the car since then.

I urge everyone to make sure to check that these positioning bolts are firmly in place (I could not move the ones on my old splines) as they came undone on my car before I even got through one set of brake shoes and must now be somewhere adding to the roadside junk. Luckily no damage was done and I think I can locate some more positioning screws from my supply of used splines (if I can get them out) but it could have resulted in my drums being scored or worse still a serious accident.
