BALL BEARING STEERING DAMPERS

By Bill Button

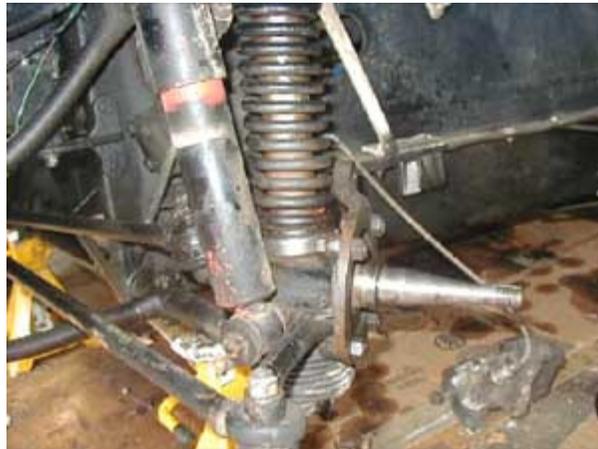
I cut the rebound spring removing 2 coils. Just trying to give the stub axle room to move. I may shorten the upper spring. However I will take it to a "Spring Company" so that I get the proper hardness etc.
